I would like to ask about help with programming external flash issue.

[SETUP]

1. J-Link Plus : HW v10.1, 16-36 (YY – WW), V6.30b;
2. J-Link Base : HW v8.0, 10-04 (YY – WW), V6.30b;
3. J-Flash - SW V6.30b / J-Link commander - V6.30b;
4. J-Flash - SW V6.20e / J-Link commander - V6.20e;
5. NXP LPC1853
6. WINBOND W25Q128FV – Serial flash memory (DUAL/QUAD SPI)
7. Keil uVision for ARM

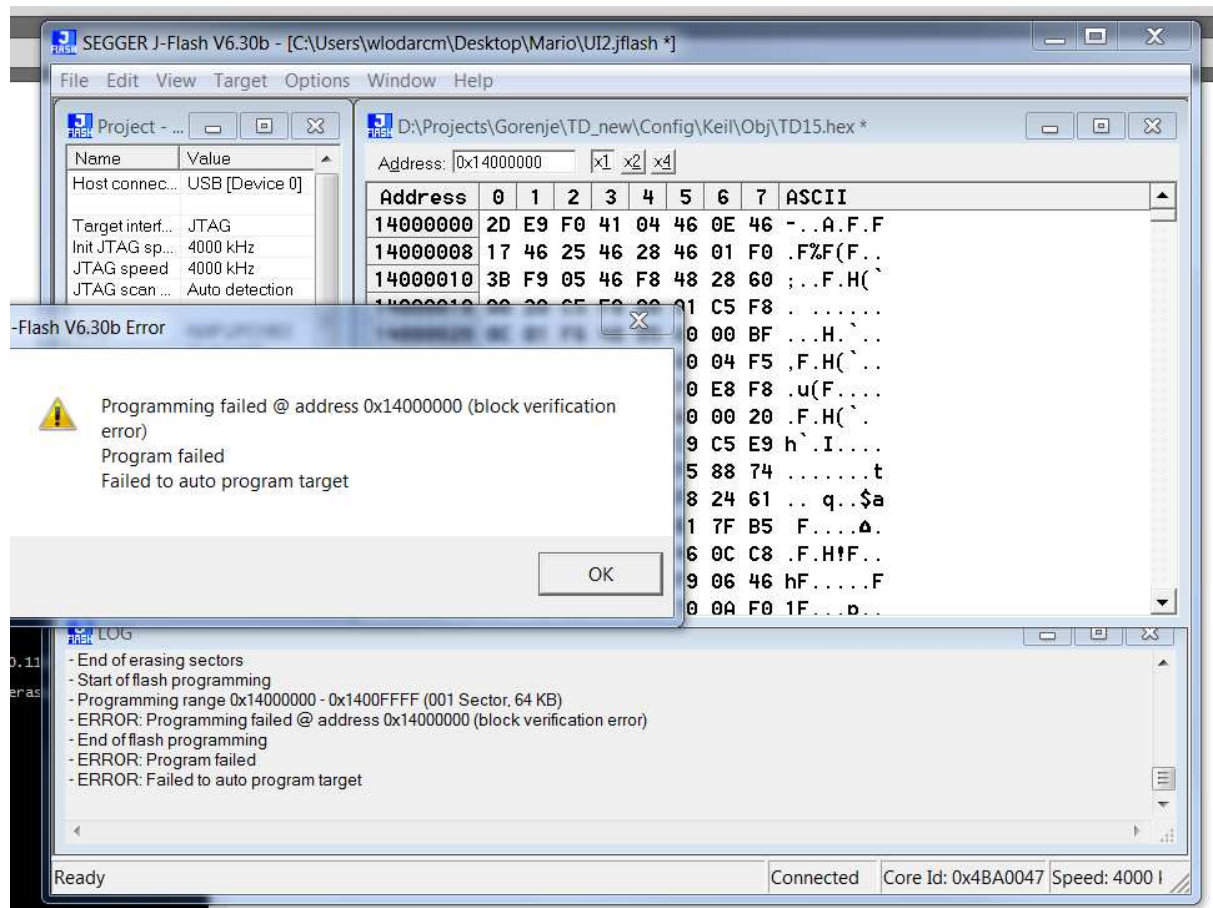
JFlash :

Sometimes during programming process, J-Link can not program external flash (6.).

There is problem with access to data block – block verification error.

Sometimes it is not a start address of external flash memory but a hundreds bytes later.

***** Error: Programming failed @ address 0x14000000 (block verification error)
Error while programming flash: Programming failed.

To “fix” our flash, we have to erase flash by **Keil** with flash algorithm written by us (.FLM). Very often it doesn't work for the first time.

HOW KEIL WORKS : Keil is programming internal NXP memory, and after that, step by step it is coping data from internal memory to external (in the meantime NXP gets new part of data).

After that, we have access to flash again, and now programing with SEGGER tools and J-Link is possible.
